Subject: Timberline Village – 628, ODW# 88388, Lewis County: Part B Water System Plan Update

Water System Plan

Timberline Village #628

WSID: 88388

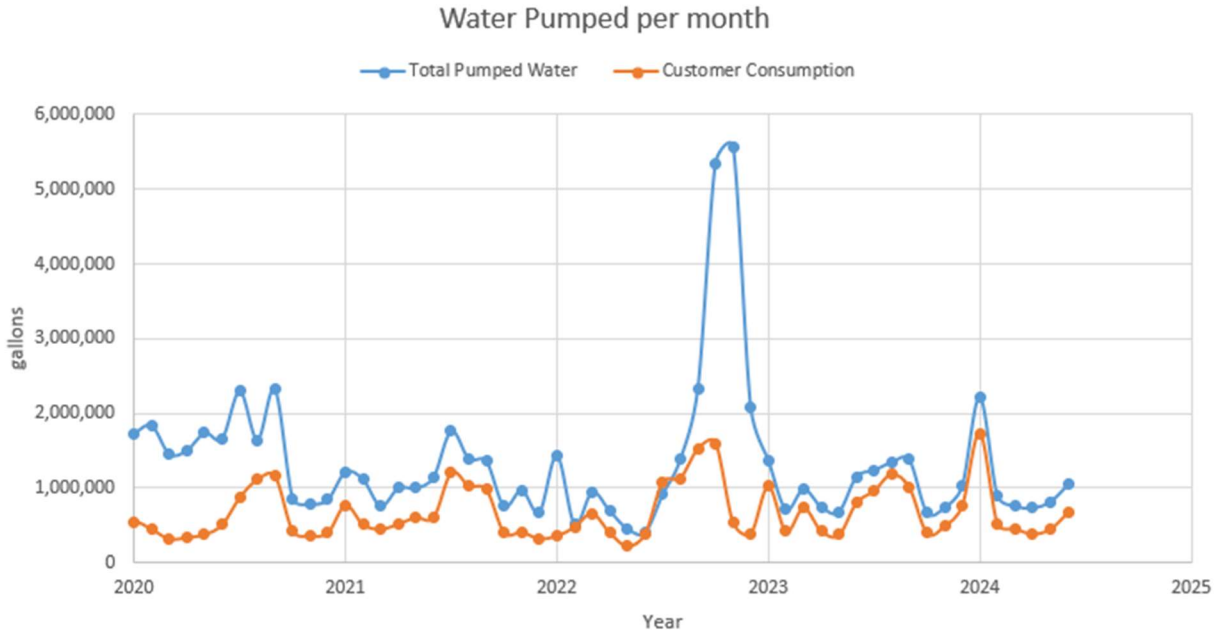
Figure 2-1 Total water pumped and customer use per month
(Jan. 2020 to June 2024, each point represents one month)

Average DSL and consumption have been reduced since acquisition of the system by Thurston PUD and have been within the water right for the past 48 months, with the notable exception of the fire and main rupture event of Fall 2022 (see Section 4.6 for detailed discussion of event). It is clear in the chart below that this event is an aberration from the norm and should not be considered in forecasting future system demand.
